2010 Stream Quality Monitoring Report

Columbia Run Stream Survey
Columbia Run Conservation Area

Report Compiled by: Marlo Perdicas
Natural Resources Management Department
Metro Parks, Serving Summit County
975 Treaty Line Road
Akron, OH 44313
(330) 865-8057

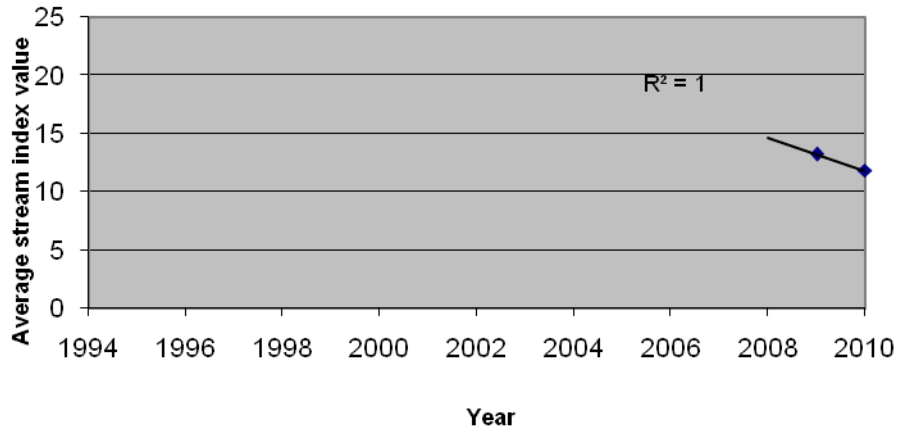
Figure 21. Average stream quality index value for Wetmore Conservation Area, 2010.

Sand Run 3 and 4 had slight declines in the average assessment scores in 2010. Both site's maximum cumulative index values were Fair. Wetmore Road Conservation Area (AVK1) scored a Fair its third year in the program.
